LN03 Series Problem Determination Guide

Order Number EK-OLN03-DG-001

Digital Equipment Corporation

1st Edition, March 1991

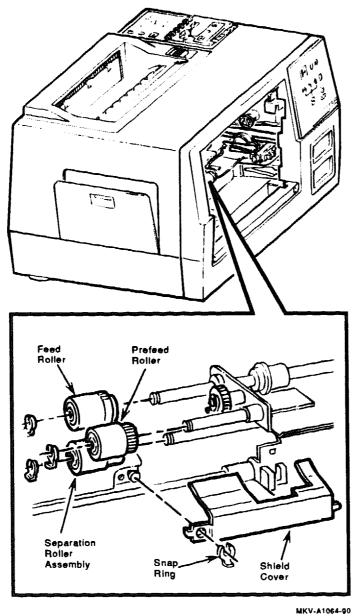
Figure 2-1 Feed and Separation Rollers

- Ensure that the paper is within specification (16 24 lb.). Refer the customer to the Digital Laser Printers: Guide to Paper and Other Media (EK-LASER-GD). Consult with the customer on unique media use.
- Advise the customer to fan the paper prior to loading it into the tray.
- Ensure that the paper size switch is in the correct position.
- Check the cause of binding and adjust/replace hardware components as required.
- Refer to Section 2.9.17 or Section 2.9.18 to troubleshoot a hardware problem. Also refer to the appropriate pocket service guide and IPB to replace or adjust the following components, if required (see Figure 2-1):

- Prefeed roller replacement
- Feed roller replacement
- Separation roller replacement
- Paper feed clutch adjustment
- Paper transport clutch adjustment

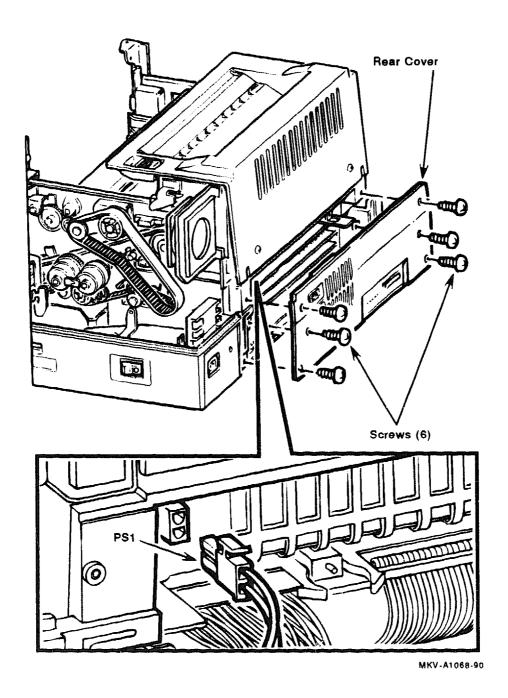
Figure 2-2 LN03 Power Supply

If, after making all the preceding verifications the problem still exists, replace the power supply.

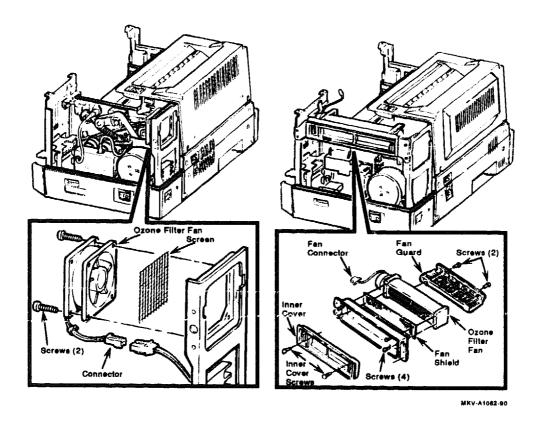
Figure 2-3 Replacing the Ozone Screens

- The printer is located in a confined area.
- The airflow is obstructed.
- The ozone filter element or fan screen is clogged or dirty (see Figure 2-3).
- The cooling fan has a problem.
- The thermistor has failed on the fusing unit.
- The engine drive board has failed.

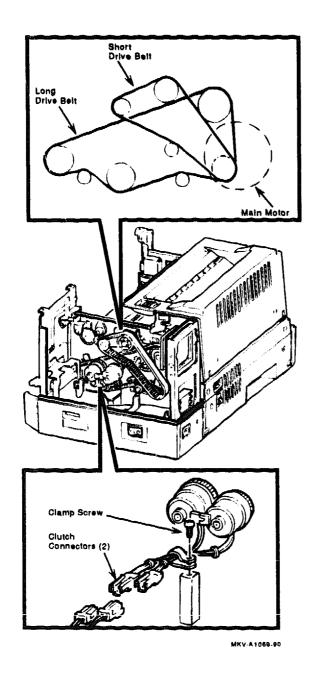
Figure 2-5 OPC Drive Belt and Gear

- Clean the OPC sensor.
- Reseat the OPC cartridge.
- Wipe the OPC synchronous mark with a lint-free cloth. Check wear on the synchronous mark.
- Replace the OPC with a customer-supplied OPC cartridge and install the LN03X-AD Maintenance Kit.
- Replace the cleaning unit.
- Replace the OPC sensor.
- Replace the engine drive board.
- Replace the long drive belt (see Figure 2-5).

- Tighten the OPC drive gear (see Figure 2-5) using the following procedure:
 - Turn the OPC drive gear so that the hex set screw is facing forward. If the OPC drive gear does not turn easily, then rotate the development drive gear counterclockwise which in turn rotates the cluster of gears including the OPC drive gear.
 - Remove the hex set screw and apply a small amount of Loctite® to the threads.
 - Position the gear flush with the end of the shaft.
 - Replace and tighten the hex set screw.
 - Replace the other parts that were removed.

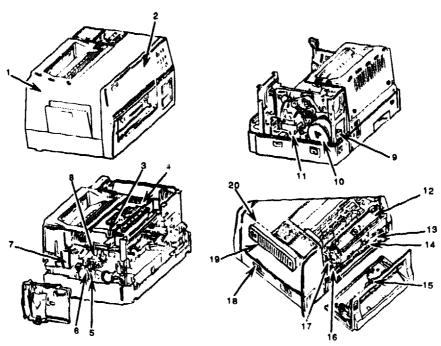
Figure A-1 Field Replaceable Units (FRUs)

In the LN03A, some of the FRUs have changed in appearance and location. Figure A-1 lists the changed FRUs and their part numbers. These FRUs are not interchangeable with the base LN03 printer. Refer to the LN03A Pocket Service Guide (EK-LN03A-PS) for locations, removal and replacement procedures, and troubleshooting techniques.

ltem	Description	PN
1	Top Cover	29-26063
2	Development Unit	29-26088
2 3	Optical Housing Unit	29-26070
4	Scanner Motor Drive Board	29-26074
5	Lower Transport Roller	29-26079
6	Registration Sensor	29-26078
6 7	OPC Counter	29-26056
8	OPC Sensor	29-26076
9	AC Bracket Assembly (100 V)	29-26053
	AC Bracket Assembly (200 V)	29-26060
10	Main Motor Assembly	29-26067
11	High Voltage Power Supply	29-26097
12	Fusing Unit (100 V)	29-26089
13	Engine Drive Board	29-26098
14	Controller Board	29-25334
15	Exit Sensor	29-26077
16	Power Supply (100 V)	29-26096
	Power Supply (200 V)	29-26099
17	Fusing Unit Heater (115 V)	29-25208
	Fusing Unit Heater (200 V)	29-25594
18	Total Counter	29-26058
19	Ozone Filter	29-26055
20	Ozone Filter Fan	29-26054

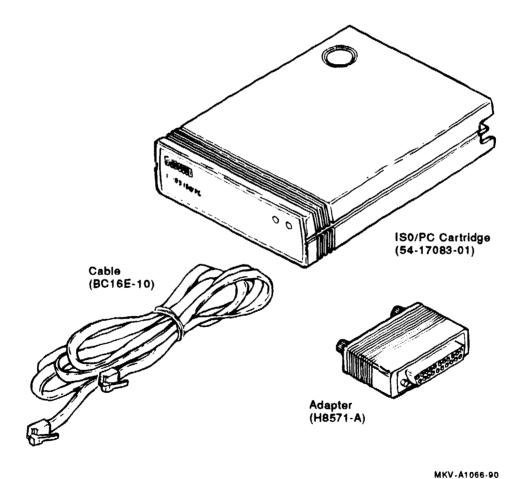
Figure C-2 ISO/PC Cartridge, Cable, and Adapter

Power up the LN03 PLUS and the VAXmate.

Check the green LED on the front of the cartridge to ensure that it is in the selected mode.

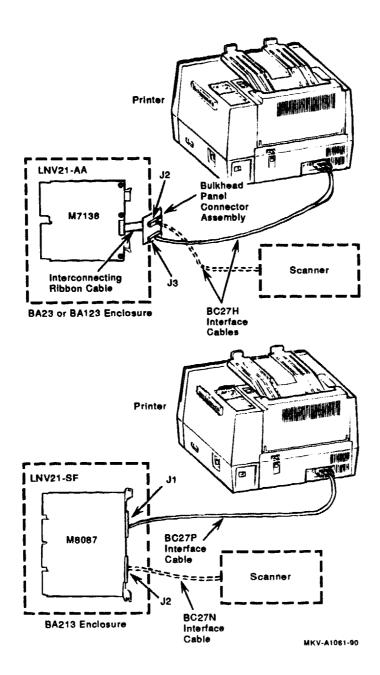
Figure D-1 Printer/Interface Configurations

In most cases, the LN03Q is used with an MD300 optical page scanner. For more information on the MD300, see the Scanning System Pocket Service Guide (EK-MD300-PS). Figure D-1 shows the LN03Q configurations.

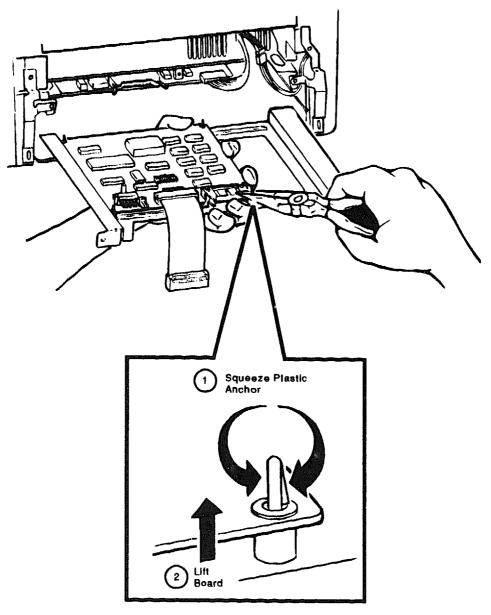
Figure D-2 Video Interface Module (VIM)

The only VIM error that displays on the LN03Q indicator panel is the fatal controller error. The controller symbol flashes with the service symbol and the number 7. This indicates a VIM failure.
