TECH TIP INDEX

DEVICE: TK50/TQK50 DESCRIPTION

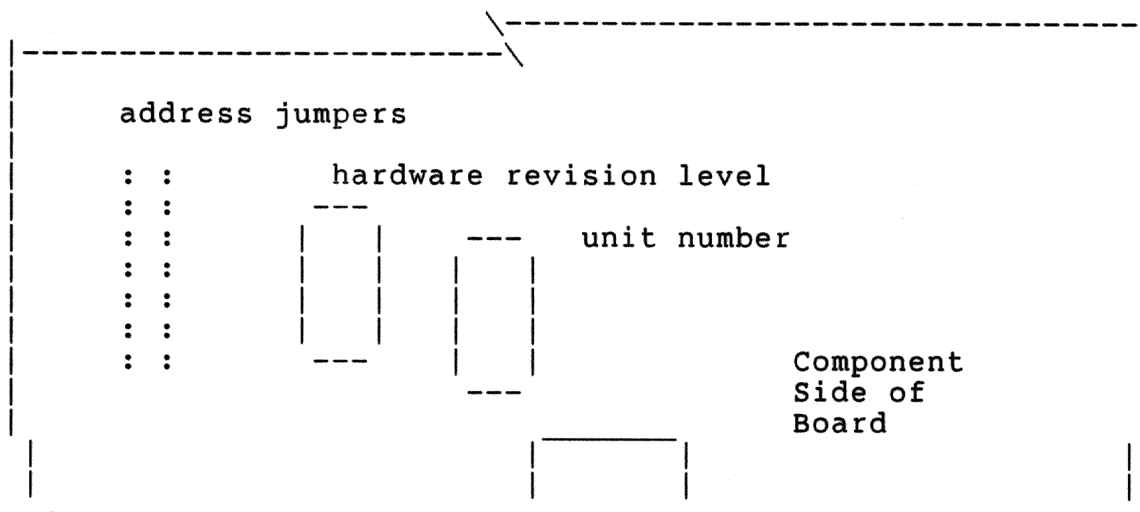
CSR ADDRESS TABLE (1=IN 0=OUT)

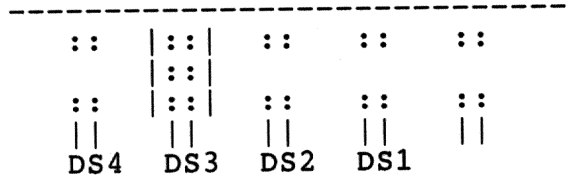
Pin Numbers	Connection
1 to 16	Not used (nearest front of drive)
2 to 15	Intact
3 to 14	Intact
4 to 13	Intact
5 to 12	Broken
6 to 11	Intact
7 to 10	Broken
8 to 9	Broken (nearest rear of drive)

Front of drive

HDA(Top)

Rear of drive

PCB(Base)

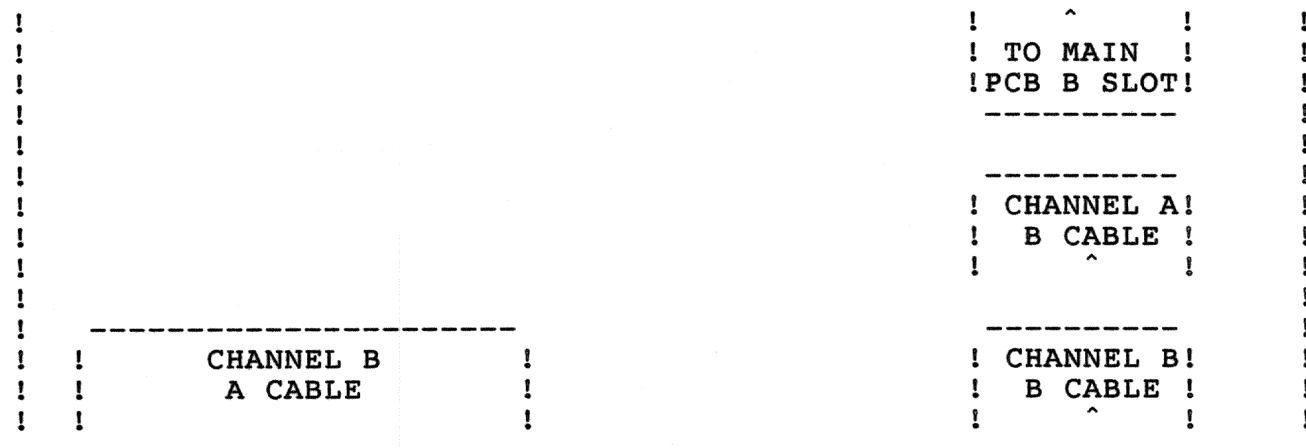
Dual channel card : (Viewed from above)

The 'A' cable for channel A plugs directly into the normal A cable slot.
